# TEST REPORT

## **BM6045 Composite Cover & Aluminium Frame EN124:2015 B125 Load Bearing Test (BIF 65464)**

Document reference number - SSC-BM6045-LBT-65464-01-10-18

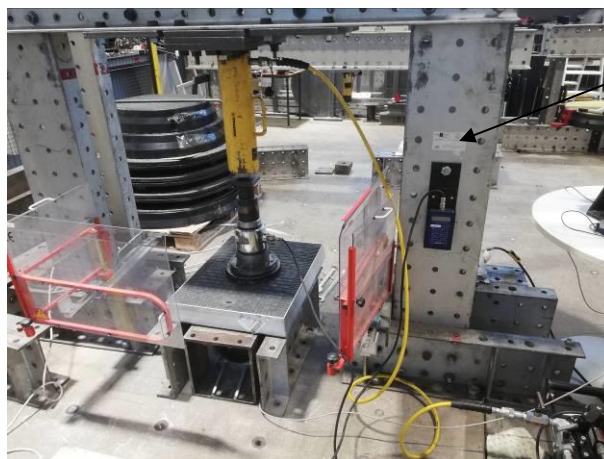
Photo.2

The test rig consists of a 'giant mecano' frame bolted to the floor and supporting an Enerpac 50 ton hydraulic cylinder. (Photo 2)

The frame sat on steel channels with shims to pack and level.

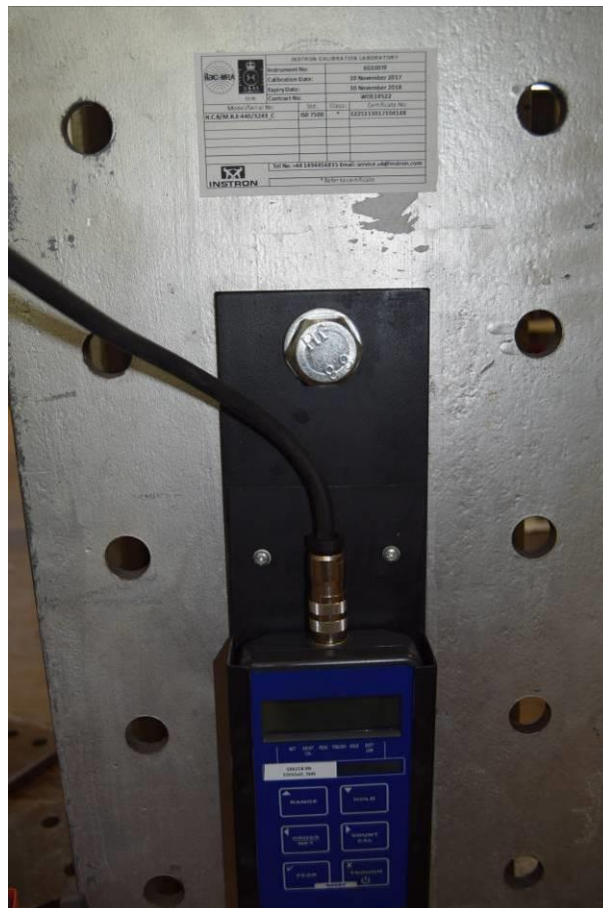
Photo.3

Calibration Sticker (Photo.3)

Test Rig ID: EG100TF (Photo.3)

Load Cell ID: 440/3243

Instron Calibration Certificate No. E225112816155035

System Class: 2

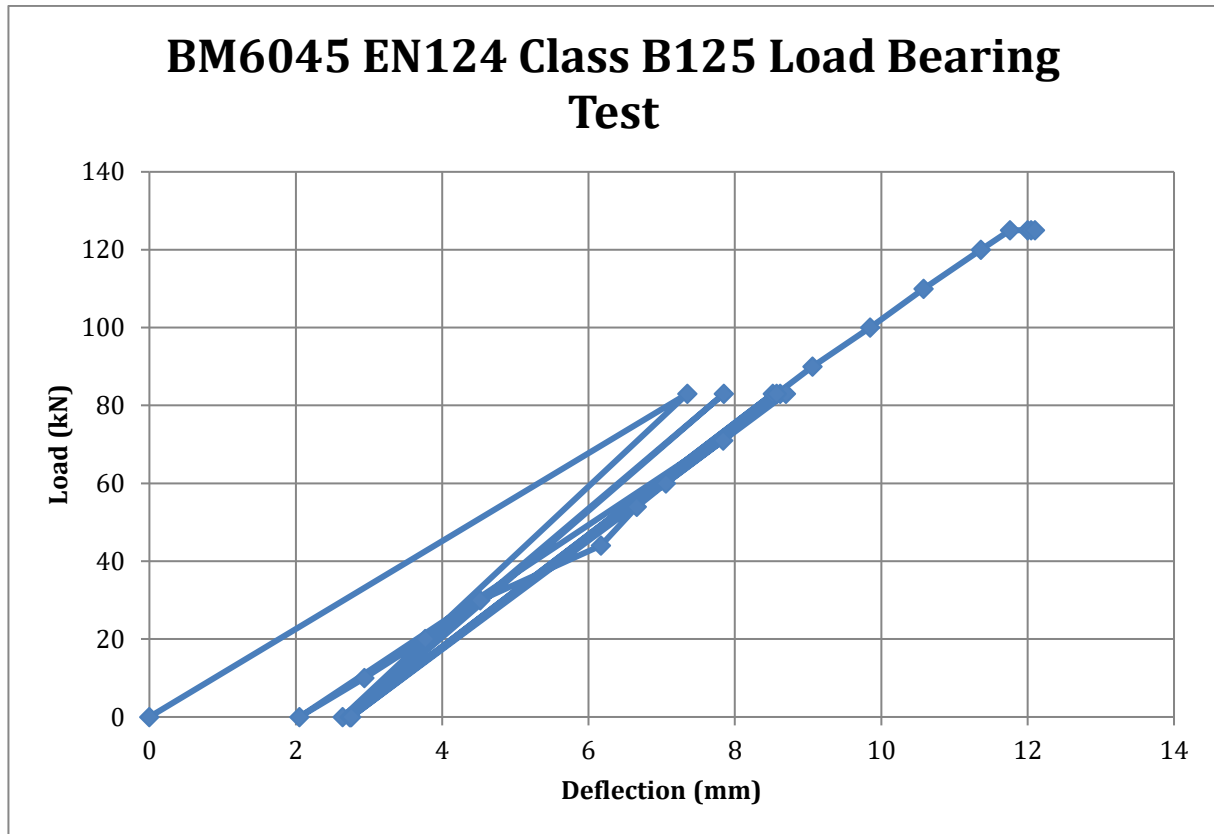
Although the standard does not require it for the load bearing test, a measuring device (linear potentiometer) was placed on the underside of the cover directly under the loading point. Deflection readings were taken throughout the test including the initial permanent set test and the results given in the following table.

<b>LOAD (kN)</b>	<b>DEFLECTION (mm)</b>	<b>REMARKS</b>
0	0.00	
83	7.35	Light cracking noises just for the 1 <sup>st</sup> cycle.
0	2.64	
83	7.85	
0	2.74	
83	8.52	
0	2.74	
83	8.62	
0	2.76	
83	8.70	
0	2.05	
10	2.94	
20	3.77	
30	4.52	
44	6.17	
54	6.66	
60	7.06	
71	7.84	
83	8.57	
90	9.06	
100	9.85	
110	10.58	
120	11.36	
125	11.76	
125 (10 seconds)	12.00	
125 (20 seconds)	12.05	
125 (30 seconds)	12.10	<b>PASS</b>
0	2.45	
192	Gauge removed	Ultimate failure

The slight difference noted between the true permanent set reading taken on the top face and that of the zero readings taken on the underside, can be explained by the fact that the underside readings show the result of the cover bedding into the frame and supports.

After the cover had passed the BS EN124 Class B125 Load Bearing Test the linear potentiometer was removed from under the cover to avoid damage.

The cover was then loaded further until ultimate failure occurred at 192kN.
