## **TEST REPORT**

### **BM8080 Vented EN124 B125 Cover Test No.3 BIF - 11083**

**Client: Structural Science Composites Ltd.**

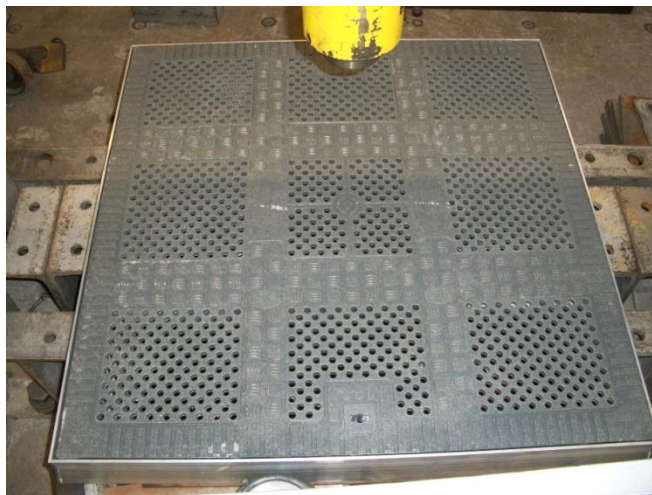
Photo.1

The cover supplied is a BM8080, 860mm x 860mm x 85mm overall composite cover. (Photo.1)  
**Cover No. – 11083**

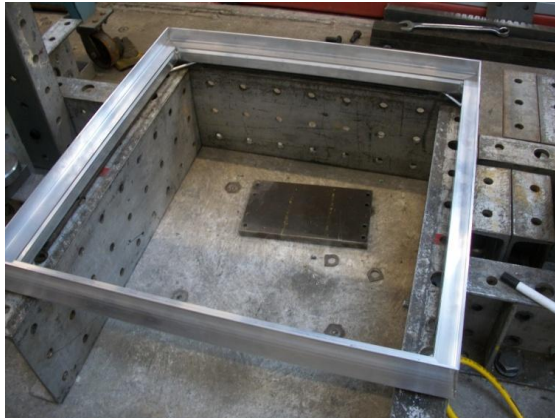
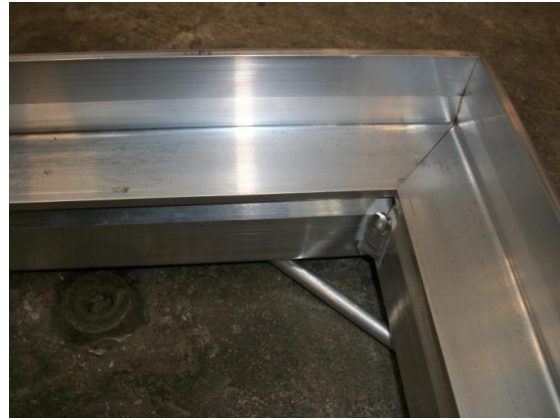
Photo.2

The frame supplied was of aluminium section welded in the four corners with an 8mm round bar tack welded on the underside in each corner. There was a clear opening of 800mm x 800mm (Photos.2 & 3)

The frame showed no signs of any damage.

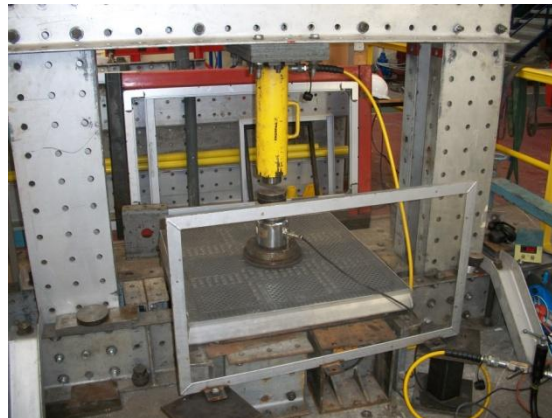
Photo.4

The test rig consists of a 'giant mecanno' frame bolted to the floor and supporting the Enerpac 50 tonne hydraulic cylinder. The cover and frame sat on steel channels, with 50mm x 12mm steel plates and shims to support and level. (Photo. 4)

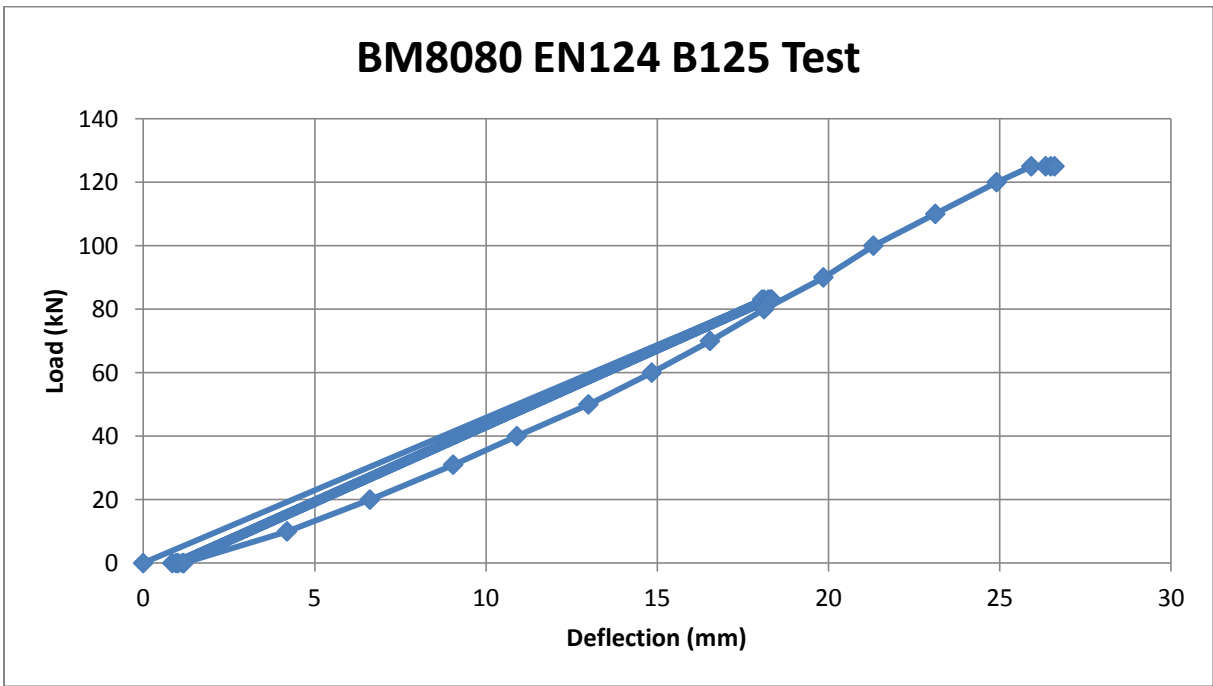
### BM8080 EN124 B125 Test

The cover was loaded to 2/3 of the test load and then released. This was repeated five times. It was then loaded to try and achieve the 125kN test load.

**In accordance with EN124 Clause 8.3.1 the permanent set of the cover was 1.98mm which is within the permissible stated in Table 8 of the standard. ( $1/100 \times 800 = 8.00\text{mm}$ ).**

**The cover reached the test load of 125kN and held for the required 30 seconds so therefore passed the EN124 B125 load test.**

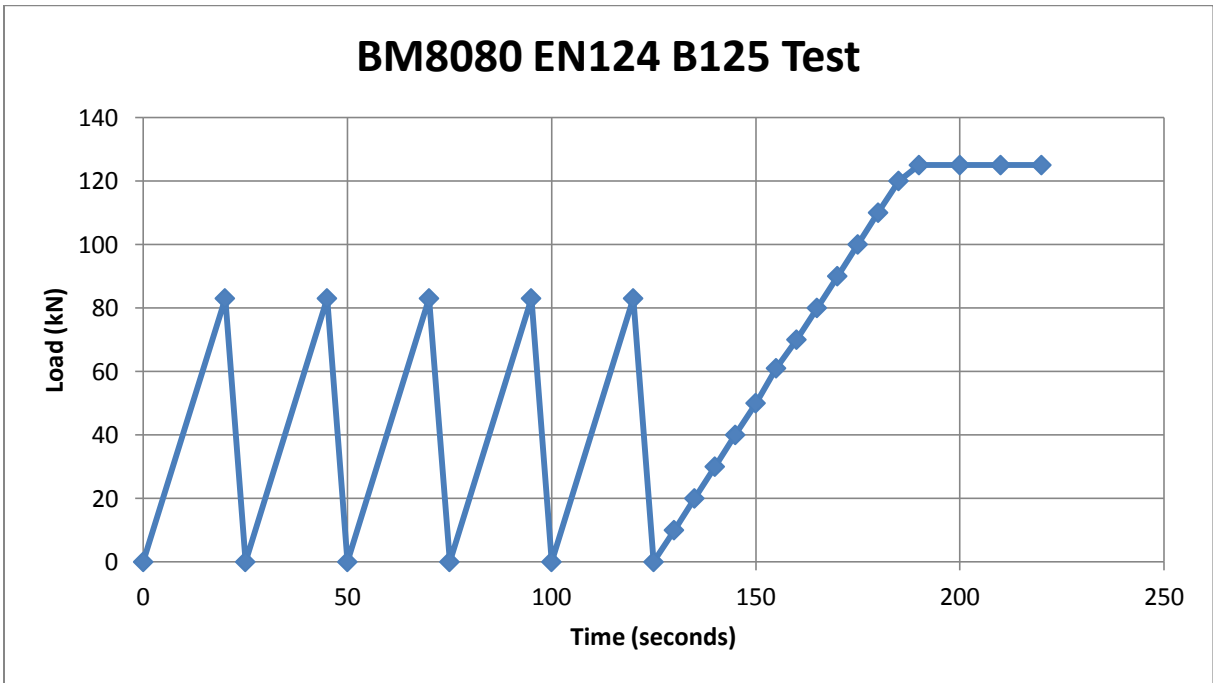
### BM8080 EN124 B125 Test

After the cover had been loaded to the test load of 125kN and held for 30 seconds it was unloaded to zero and a permanent set of 1.98mm measured.
