TEST REPORT

CR106 Composite Cover & Frame EN124:2015 C250 Load Bearing Test (BIF 47475)

Document reference number - SSC-CR106-LBT-47475-04-10-18

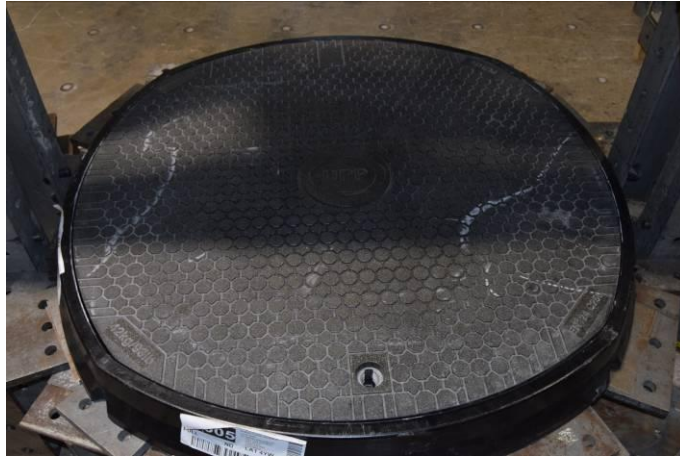
Photo. 1

The cover supplied is a round CR106 composite cover (Photo. 1)
Cover No. - 47475

A composite frame was also supplied with a clear opening of 1060mm.
Frame No. - 81644

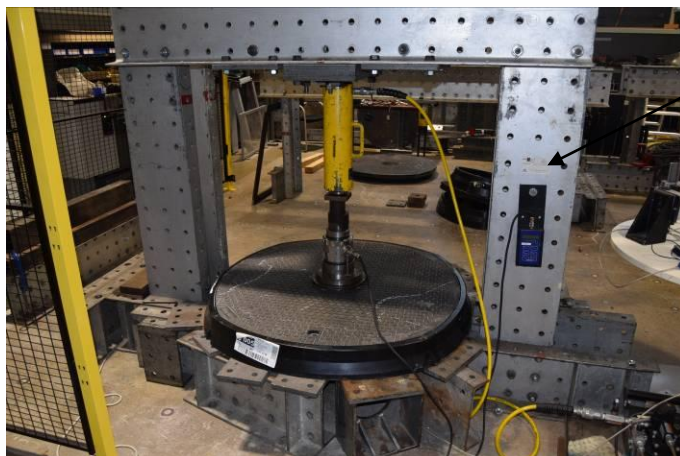
Photo.2

The test rig consists of a 'giant mecano' frame bolted to the floor and supporting an Enerpac 50 ton hydraulic cylinder. (Photo 2)

The frame sat on steel channels with plates and shims to pack and level.

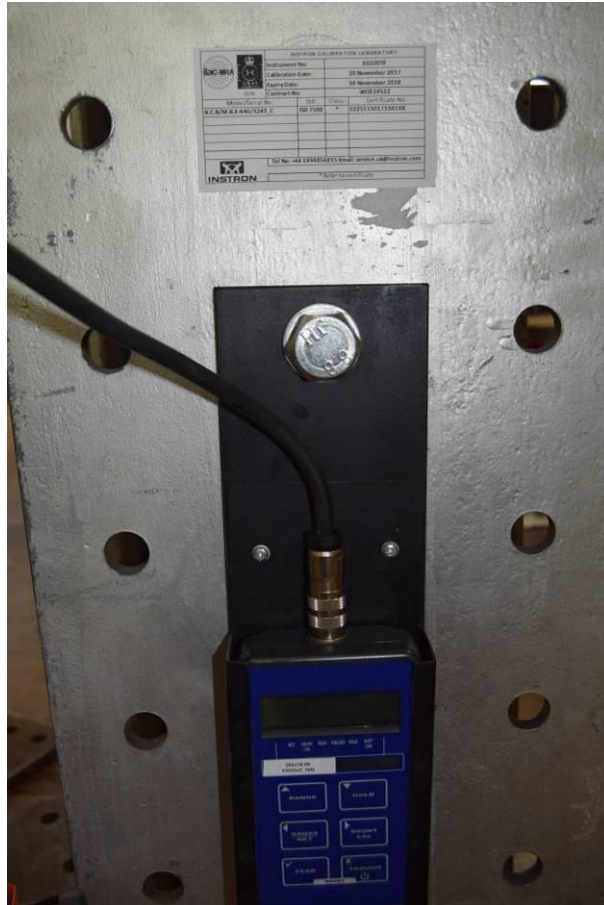
Photo.3

Calibration Sticker (Photo.3)

In accordance with the EN124-1:2015 standard the load cell and test rig complies with EN ISO 7500-1:2004 minimum Class 3.

Instron Calibration Certificate No. E225112816155035

System Class: 2

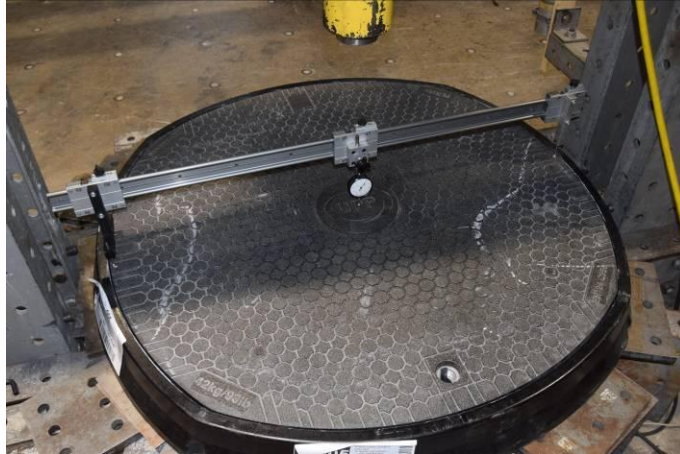
Photo.4

Photograph 4 below shows the initial reading being taken for the permanent set test.

Initial Reading	0.00mm
Reading after 5 cycles	0.49mm
Permanent Set	0.49mm

Permissible permanent set for a C250 test is $\frac{CO}{300} = 1060/300 = 3.53\text{mm}$

Therefore cover passes the permanent set test.
