TEST REPORT

CR90 Composite Cover & Frame EN124:2015 Class C250 Load Bearing Test (BIF 105854)

Document reference number - SSC-CR90-LBT-105854-29-10-19

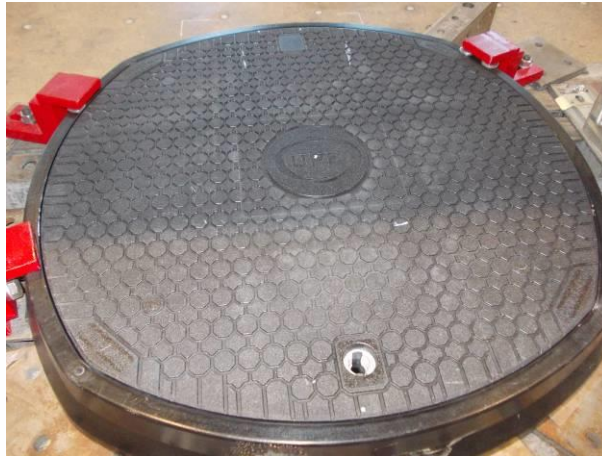
Photo. 1

The cover supplied is a round CR90 composite cover (Photo. 1)

Cover No. - 105854

A composite frame was also supplied with a clear opening of 900mm.

Frame No. - 100849

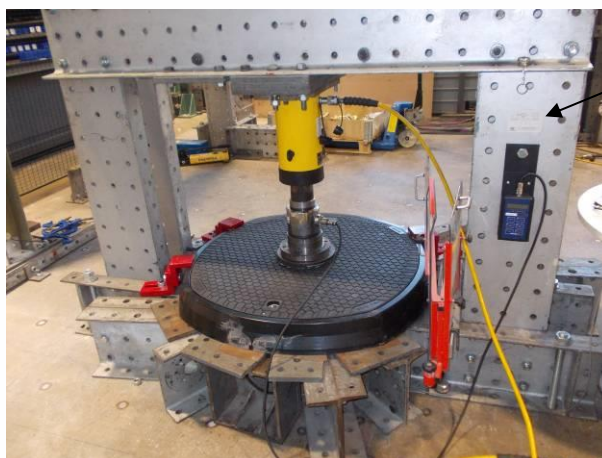
Photo.2

The test rig consists of a 'giant mecano' frame bolted to the floor and supporting an Enerpac 90 ton hydraulic cylinder. (Photo 2)

The frame sat on steel channels with plates and shims to pack and level.

In accordance with the EN124-1:2015 standard the load cell and test rig complies with EN ISO 7500-1:2004 minimum Class 3.

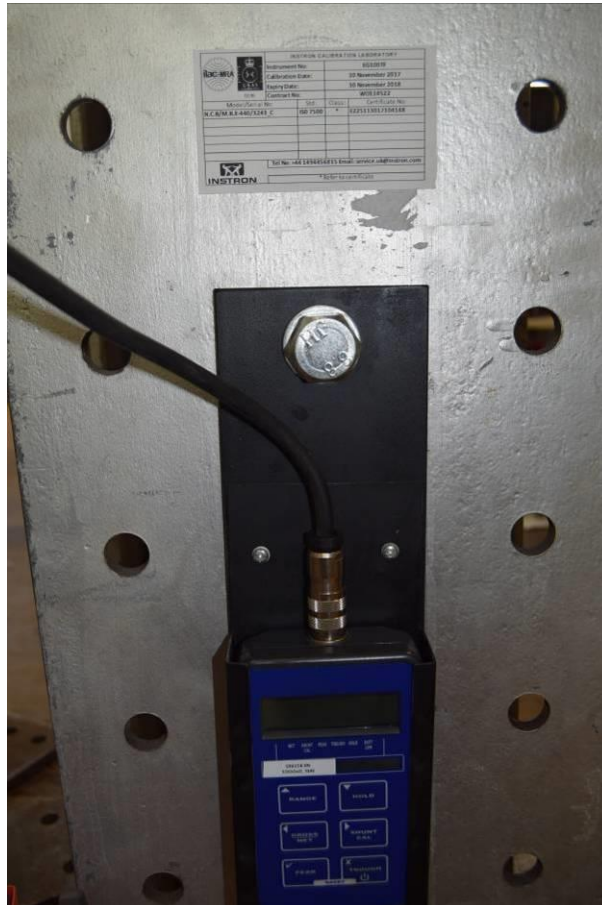
Photo.3

Calibration Sticker (Photo.3)

Test Rig ID: EG100TF

Instron Calibration Certificate No. E225112816155035

System Class: 2

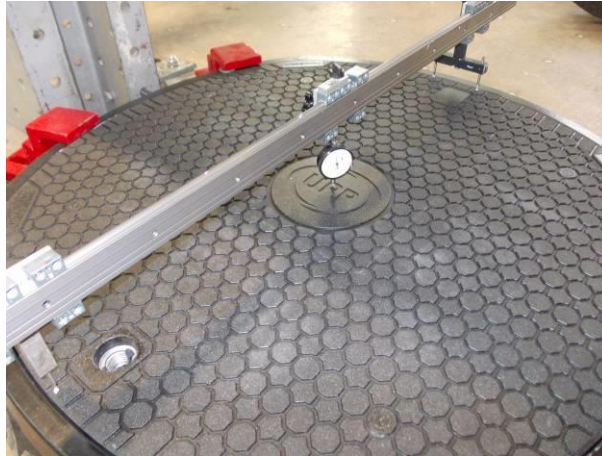
Photo.4

Photograph 4 below shows the initial reading being taken for the permanent set test.

Initial Reading	0.00mm
Reading after 5 cycles	1.01mm
Permanent Set	1.01mm

Permissible permanent set for a C250 test is $\frac{CO}{300} = 900/300 = 3.00\text{mm}$

Therefore cover passes the permanent set test.
