TEST REPORT

DM6 Composite Cover & Frame EN124:2015 D400 Load Bearing Test (BIF 66155)

Document reference number - SSC-DM6-LBT-66155-19-12-17

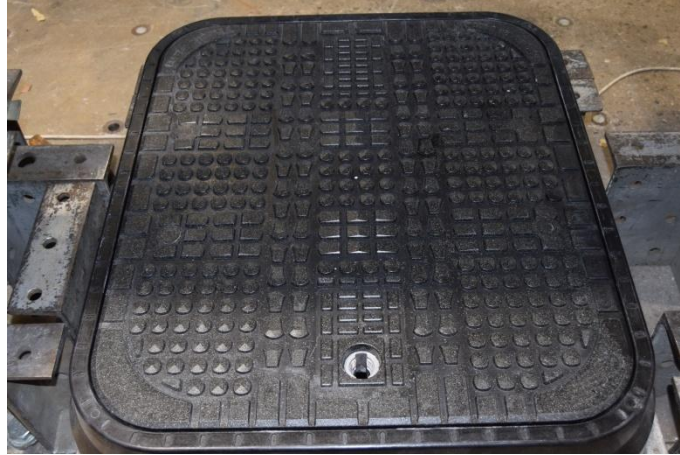
Photo. 1

The cover supplied is a rectangular DM6 composite cover (Photo. 1)

Cover No. – 66155

A composite frame was also supplied with a clear opening of 600mm.

Frame No. – 66197

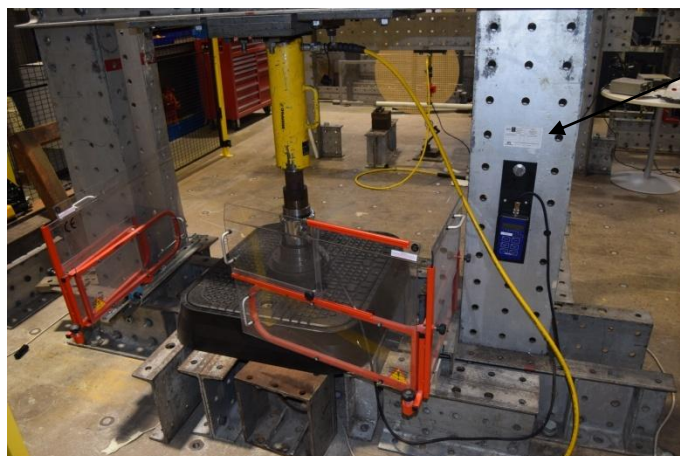
Photo.2

The test rig consists of a 'giant mecano' frame bolted to the floor and supporting an Enerpac 50 ton hydraulic cylinder. (Photo 2)

The frame sat on steel channels with plates and shims to pack and level.

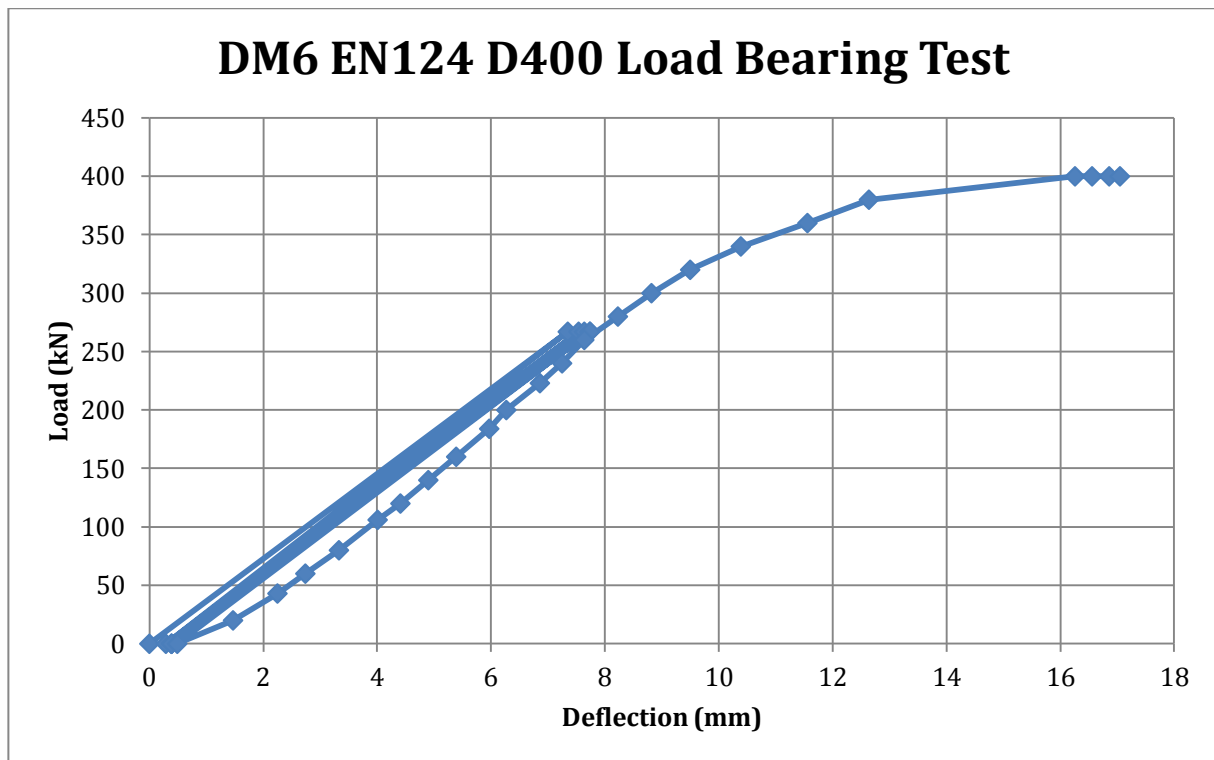
Although the standard does not require it for the load bearing test, a measuring device (linear potentiometer) was placed on the underside of the cover directly under the loading point. Deflection readings were taken throughout the test including the initial permanent set test and the results given in the following table.

LOAD (kN)	DEFLECTION (mm)	REMARKS
0	0.00	
267	7.35	
0	0.29	
267	7.54	
0	0.39	
267	7.64	
0	0.39	
267	7.74	
0	0.39	
267	7.74	
0	0.49	
20	1.47	
43	2.25	
60	2.74	
80	3.33	
106	4.01	
120	4.41	
140	4.90	
160	5.39	
184	5.97	
200	6.27	
223	6.86	
240	7.25	
260	7.64	
280	8.23	
300	8.82	
320	9.50	
340	10.39	
360	11.56	
380	12.64	
400	16.26	
400 (10 seconds)	16.56	
400 (20 seconds)	16.86	
400 (30 seconds)	17.05	PASS
0	1.56	
414	Gauge removed	Ultimate failure – loud banging and cracking, crack on top face.

The cover held the test load for the required 30 seconds with no visible signs of damage.

The cover therefore passed the Load Bearing test.

After the cover had passed the Load bearing test the linear potentiometer was removed from the underside to avoid any damage and the cover reloaded up to ultimate failure, which occurred at 414kN.
