# TEST REPORT

## **DR106 Composite Cover & Frame EN124:2015 D400 Load Bearing Test (BIF 55930)**

Document reference number - SSC-DR106-55930-22-08-17

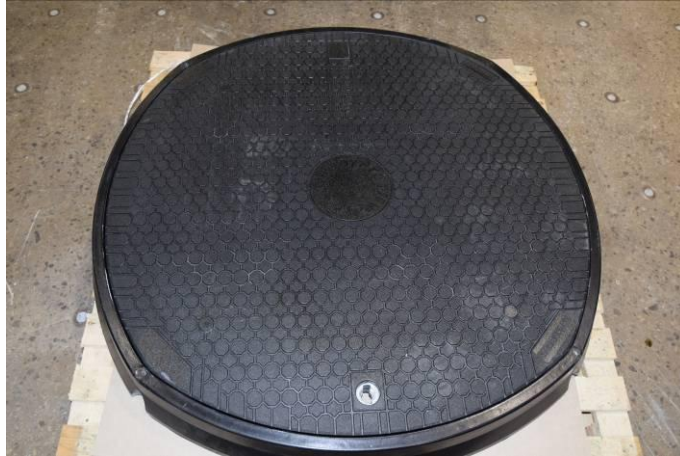
Photo. 1

The cover supplied is a round DR106 composite cover (Photo. 1)

Cover No. – 55930

A composite frame was also supplied.

Frame No. –59007

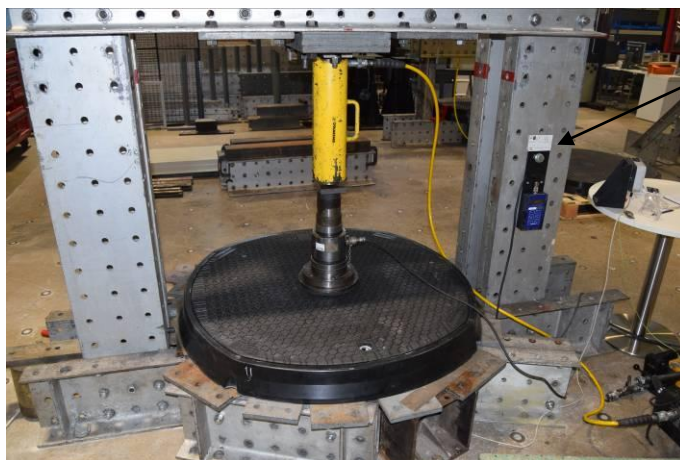
Photo.2

The test rig consists of a 'giant mecano' frame bolted to the floor and supporting an Enerpac 50 ton hydraulic cylinder. (Photo 2)

The frame sat on steel channels with shims to pack and level.

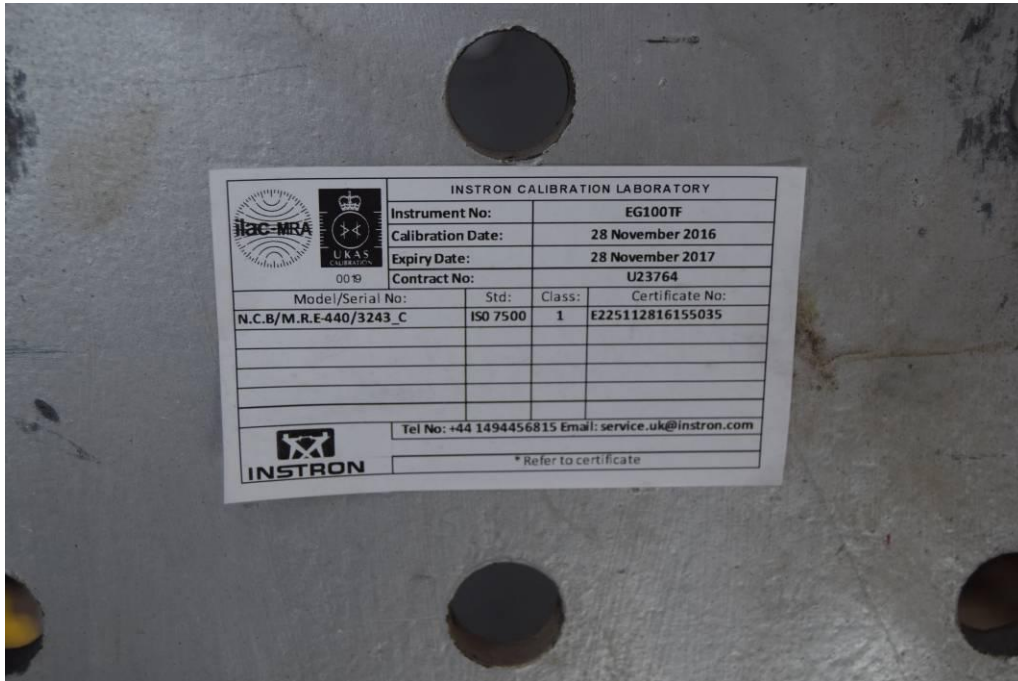
Photo.3

Calibration Sticker (Photo.3)

Test Rig ID: EG100TF (Photo.3)

Load Cell ID: 440/3243

Instron Calibration Certificate No. E225112816155035

System Class: 1

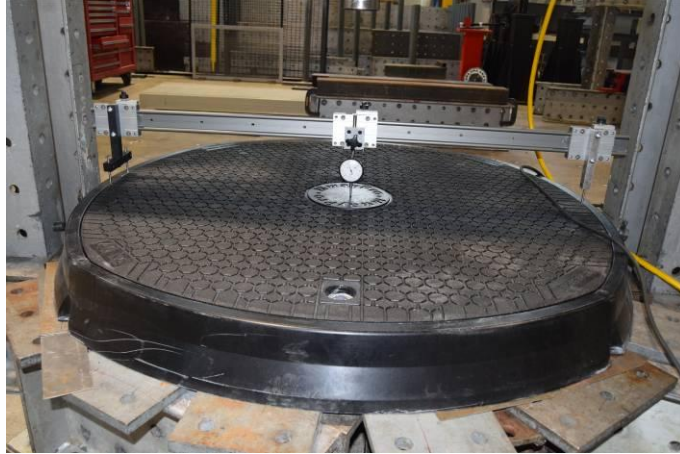
Photo.3

Photograph 3 below shows the initial reading being taken for the permanent set test.

Initial Reading	0.00mm
Reading after 5 cycles	1.08mm
<b>Permanent Set</b>	<b>1.08mm</b>

Permissible permanent set for a D400 test is  $\frac{CO}{300} = 1060/300 = 3.53\text{mm}$

**Therefore cover passes the permanent set test.**

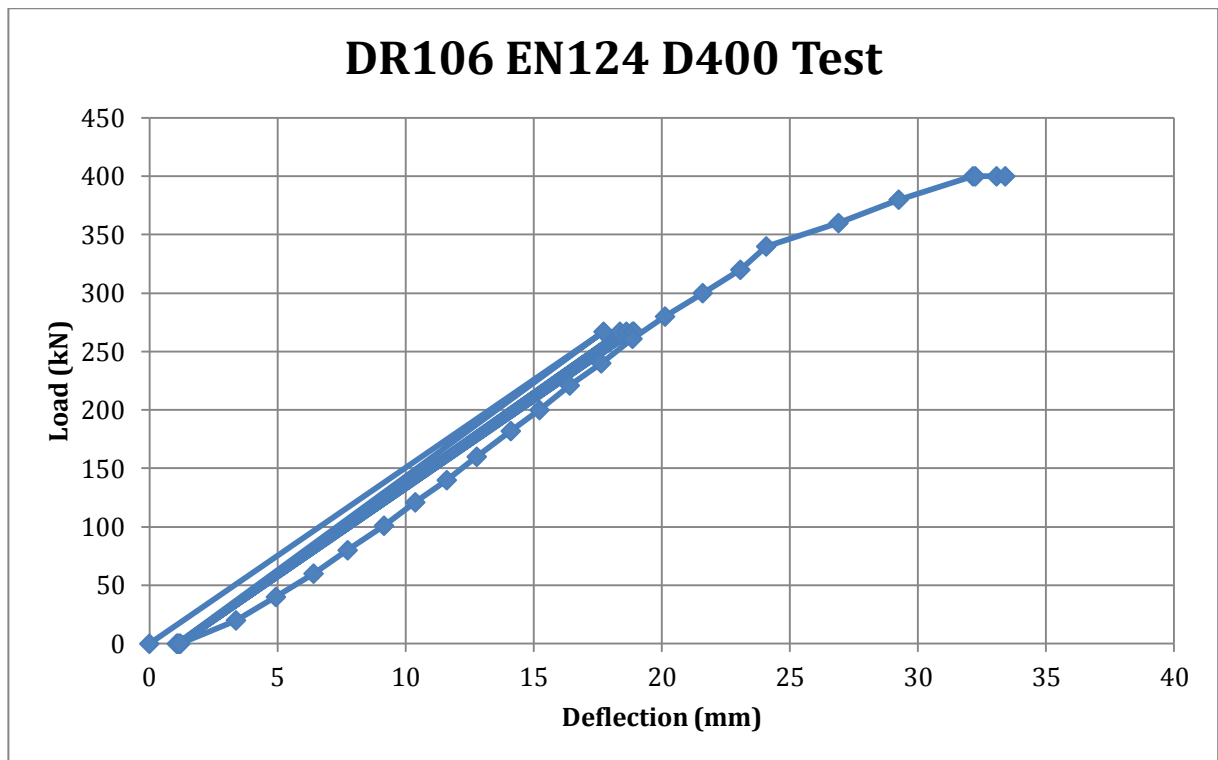
<b>LOAD (kN)</b>	<b>DEFLECTION (mm)</b>	<b>REMARKS</b>
0	0.00	
267	17.73	Light cracking noises just for the 1 <sup>st</sup> cycle.
0	1.07	
267	18.37	
0	1.12	
267	18.62	
0	1.12	
267	18.86	
0	1.20	
267	18.91	
0	1.20	
20	3.38	
40	4.94	
64	6.41	
80	7.74	
101	9.16	
121	10.38	
140	11.61	
160	12.78	
182	14.11	
200	15.23	
221	16.41	
240	17.64	
261	18.86	
280	20.13	
300	21.60	
320	23.07	
340	24.08	
360	26.90	
380	29.25	
400	32.15	
400 (10 seconds)	32.24	
400 (20 seconds)	33.07	
400 (30 seconds)	33.41	<b>PASS</b>
0	2.54	
454	Gauge removed	Ultimate failure

The cover held the test load for the required 30 seconds with no visible signs of damage.

**The cover therefore passed the Load Bearing test.**

After the cover had passed the Load bearing test the cover was reloaded up to ultimate failure which occurred at 454kN.
