TEST REPORT

DR90 Composite Cover & Frame EN124:2015 Class D400 Load Bearing Test (BIF 95371)

Document reference number - SSC-DR90-LBT-95371-24-06-19

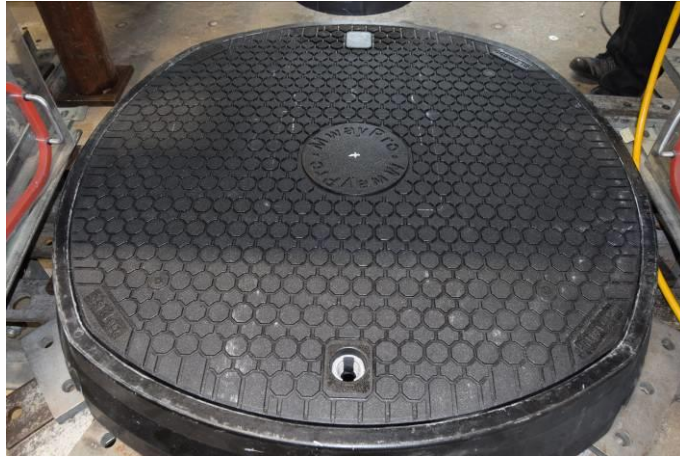
Photo. 1

The cover supplied is a round DR90 composite cover (Photo. 1)

A composite frame was also supplied with a clear opening of 900mm.

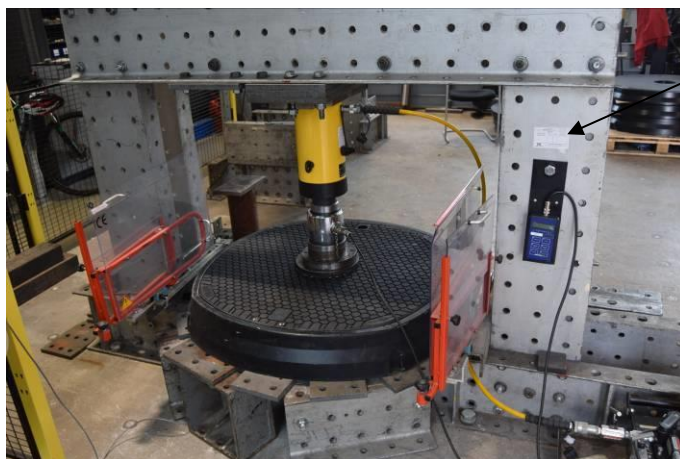
Photo.2

The test rig consists of a 'giant mecano' frame bolted to the floor and supporting an Enerpac 90 ton hydraulic cylinder. (Photo 2)

The frame sat on steel channels with plates and shims to pack and level.

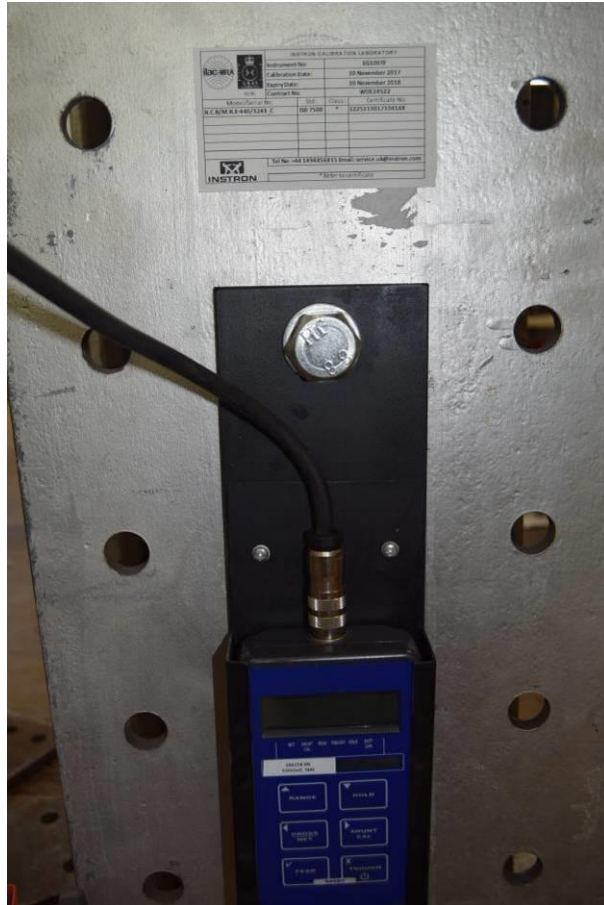
Photo.3

Calibration Sticker (Photo.3)

In accordance with the EN124-1:2015 standard the load cell and test rig complies with EN ISO 7500-1:2004 minimum Class 3.

Instron Calibration Certificate No. E225112816155035

System Class: 2

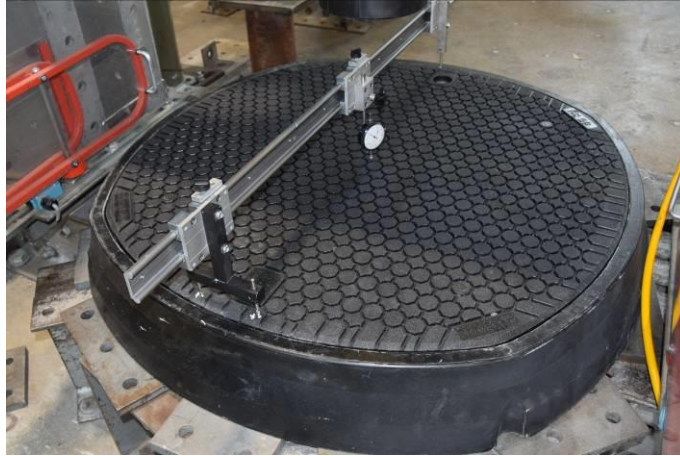
Photo.4

Photograph 4 below shows the initial reading being taken for the permanent set test.

Initial Reading	0.00mm
Reading after 5 cycles	0.81mm
Permanent Set	0.81mm

Permissible permanent set for a D400 test is $\frac{CO}{300} = 900/300 = 3.00\text{mm}$

Therefore cover passes the permanent set test.

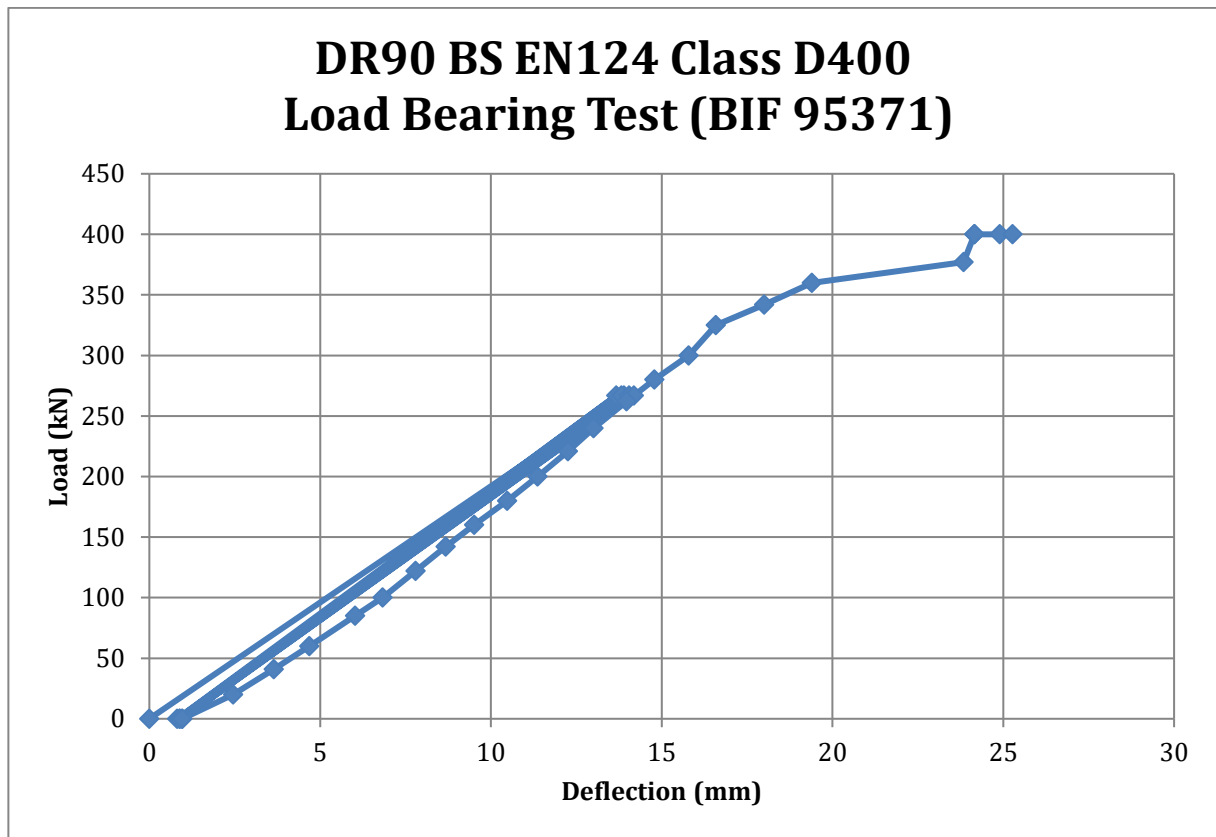
The cover held the test load of 400kN for the required 30 seconds with no visible signs of damage so therefore passed the BS EN124 Class D400 Load Bearing Test.

After the cover had passed the test it was loaded further until ultimate failure occurred at 439kN.

There was no visible damage to the frame.
