TEST REPORT

DR60 Composite Cover & Frame EN124:2015 Class D400 Load Bearing Test (BIF 83270)

Document reference number - SSC-DR60-LBT-83270-05-10-18

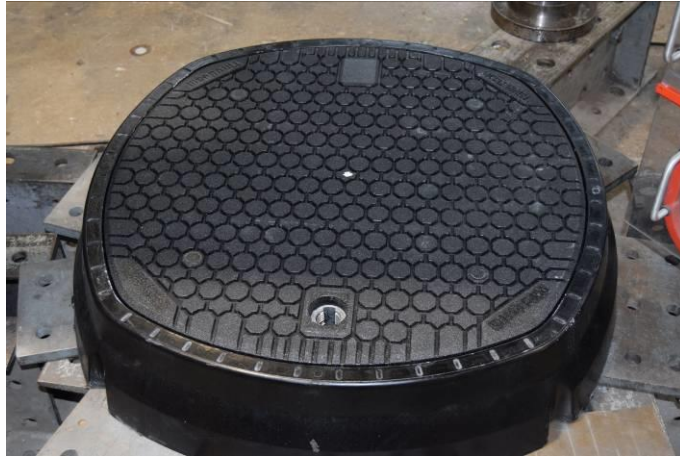
Photo. 1

The cover supplied is a round DR60 composite cover (Photo. 1)

A composite frame was also supplied with a clear opening of 600mm.

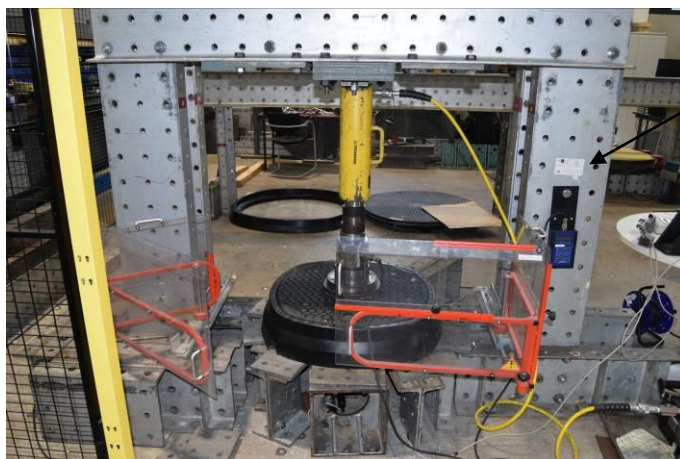
Photo.2

The test rig consists of a 'giant mecano' frame bolted to the floor and supporting an Enerpac 50 ton hydraulic cylinder. (Photo 2)

The frame sat on steel channels with plates and shims to pack and level.

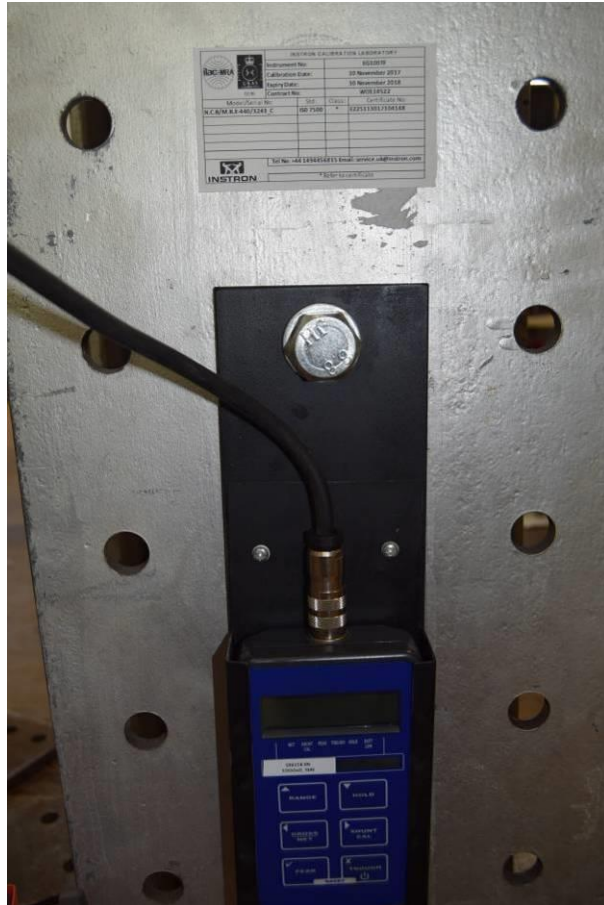
Photo.3

Calibration Sticker (Photo.3)

In accordance with the EN124-1:2015 standard the load cell and test rig complies with EN ISO 7500-1:2004 minimum Class 3.

Instron Calibration Certificate No. E225112816155035

System Class: 2

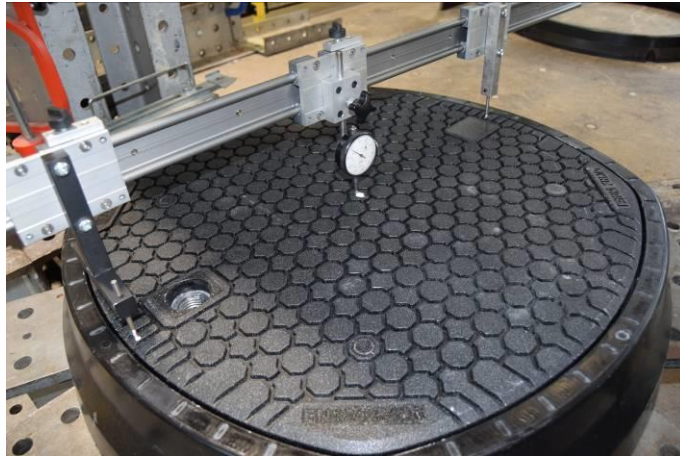
Photo.4

Photograph 4 below shows the initial reading being taken for the permanent set test.

Initial Reading	0.00mm
Reading after 5 cycles	0.82mm
Permanent Set	0.82mm

Permissible permanent set for a D400 test is $\frac{CO}{300} = 600/300 = 2.00\text{mm}$

Therefore cover passes the permanent set test.
