TEST REPORT

DR76 Composite Cover & Frame EN124:2015 Class D400 Load Bearing Test (BIF 78767)

Document reference number - SSC-DR76-LBT-78767-05-10-18

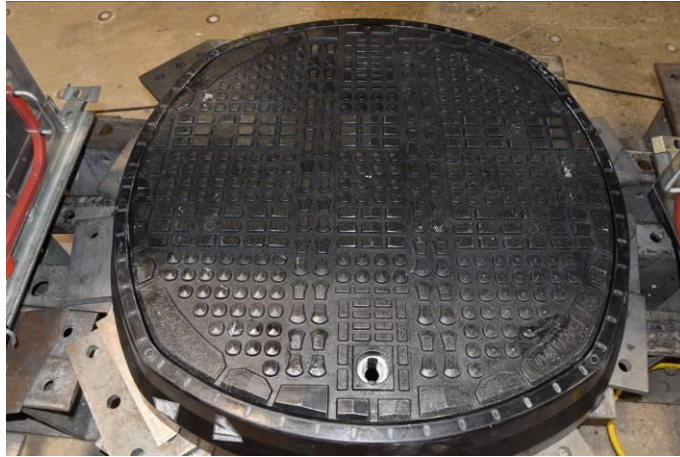
Photo. 1

The cover supplied is a round DR76 composite cover (Photo. 1)
Cover No. - 78767

A composite frame was also supplied with a clear opening of 760mm.
Frame No. - 61491

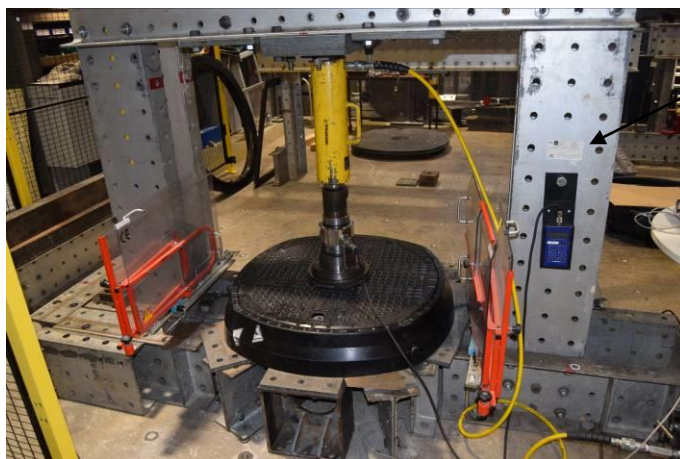
Photo.2

The test rig consists of a 'giant mecano' frame bolted to the floor and supporting an Enerpac 50 ton hydraulic cylinder. (Photo 2)

The frame sat on steel channels with plates and shims to pack and level.

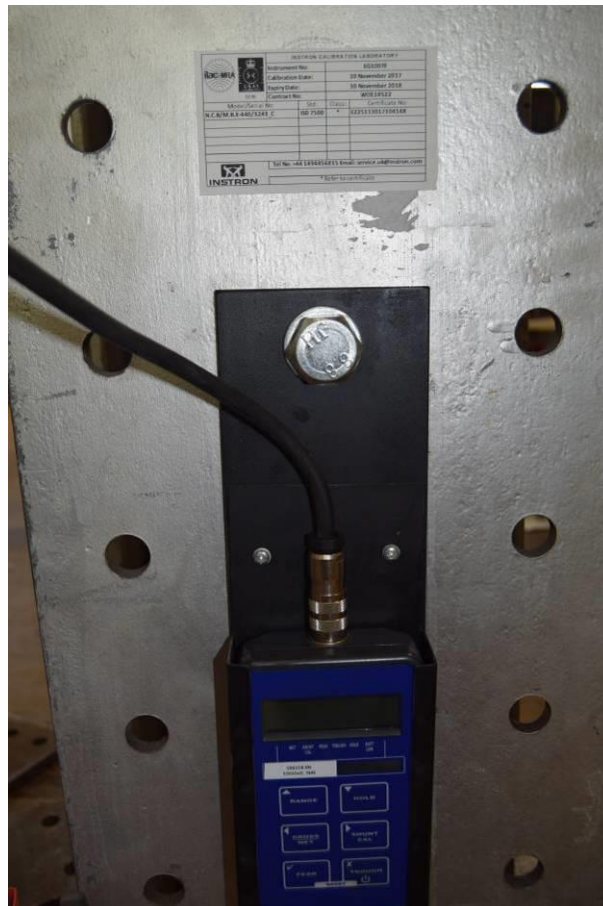
Photo.3

Calibration Sticker (Photo.3)

In accordance with the EN124-1:2015 standard the load cell and test rig complies with EN ISO 7500-1:2004 minimum Class 3.

Test Rig ID: EG100TF

Instron Calibration Certificate No. E225112816155035

System Class: 2

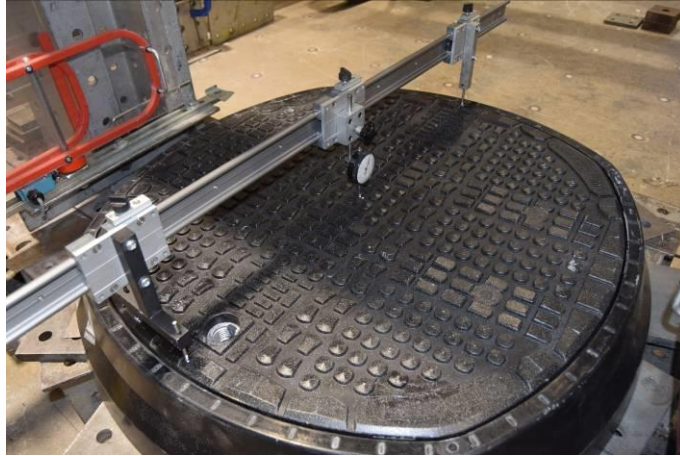
Photo.4

Photograph 4 below shows the initial reading being taken for the permanent set test.

Initial Reading	0.00mm
Reading after 5 cycles	0.49mm
Permanent Set	0.49mm

Permissible permanent set for a D400 test is $\frac{CO}{300} = 760/300 = 2.53\text{mm}$

Therefore cover passes the permanent set test.
